# INTEGRATING & TROUBLESHOOTING VMWARE WITH EMC'S MIDRANGE CLARION: DEEP DIVE

**EMC<sup>2</sup>** EMC Proven Professional Knowledge Sharing 2012

Jason L. Gates

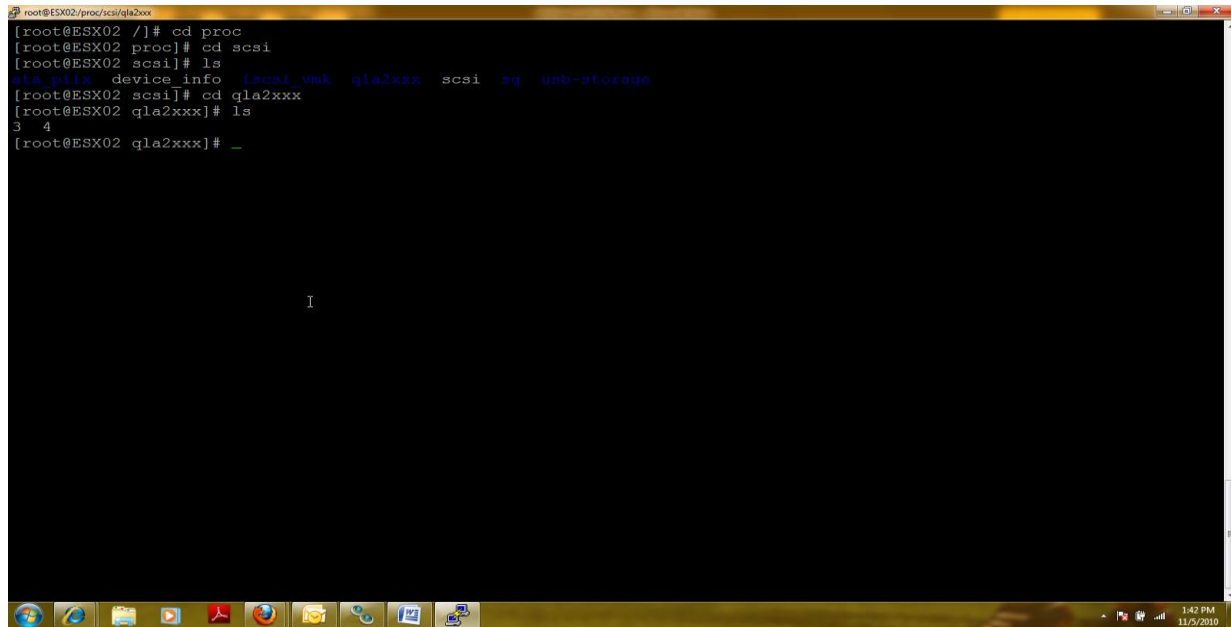
Figure 1 Using SSH as in this display, `proc/scsi/qla2xxx` is the directory that stores very useful information about the HBA. (In your environment, the HBA nomenclature could be different)

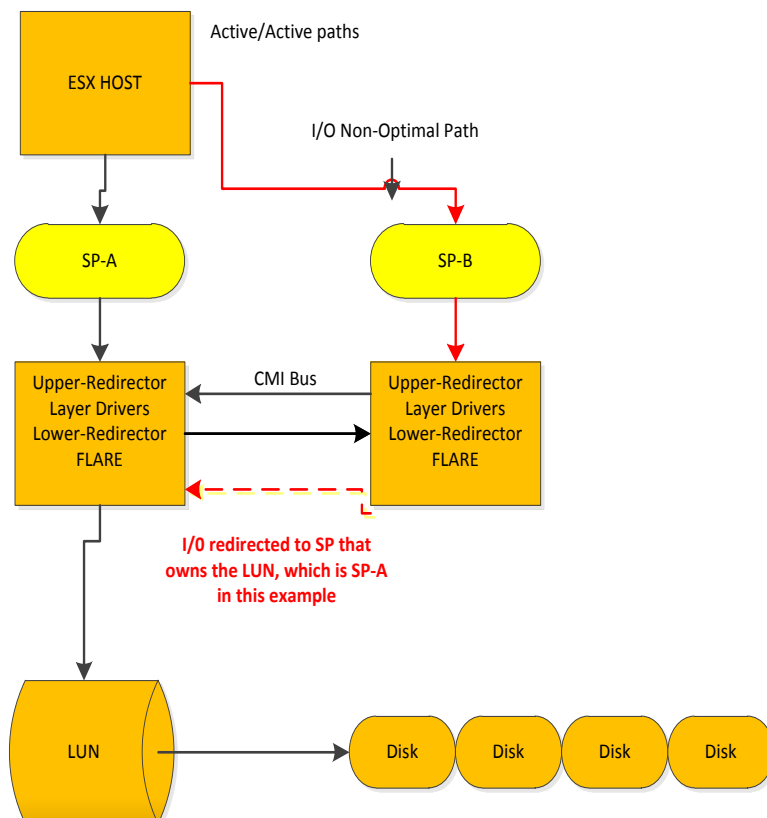
ALUA uses SCSI 3 commands that are part of the standard SCSI SPC-3 specification to determine I/O paths. Case in point, if I/O for a LUN is sent to an SP that does not own the LUN, that SP redirects the I/O to the SP that does own the LUN. The redirection is done through internal communication (upper-redirect) between the SP's; a LUN trespass is not needed and the redirection is transparent to the hosts. The diagram below illustrates ALUA behavior:

The following event code will be logged in the SP(s) event log:

“UpperRedirector 711b0000 IO is being forwarded to the other SP for processing”
